# Habitat Restoration in the Research Reserve

Brian DeGasperis

Hudson River National Estuarine Research Reserve

March 11, 2020

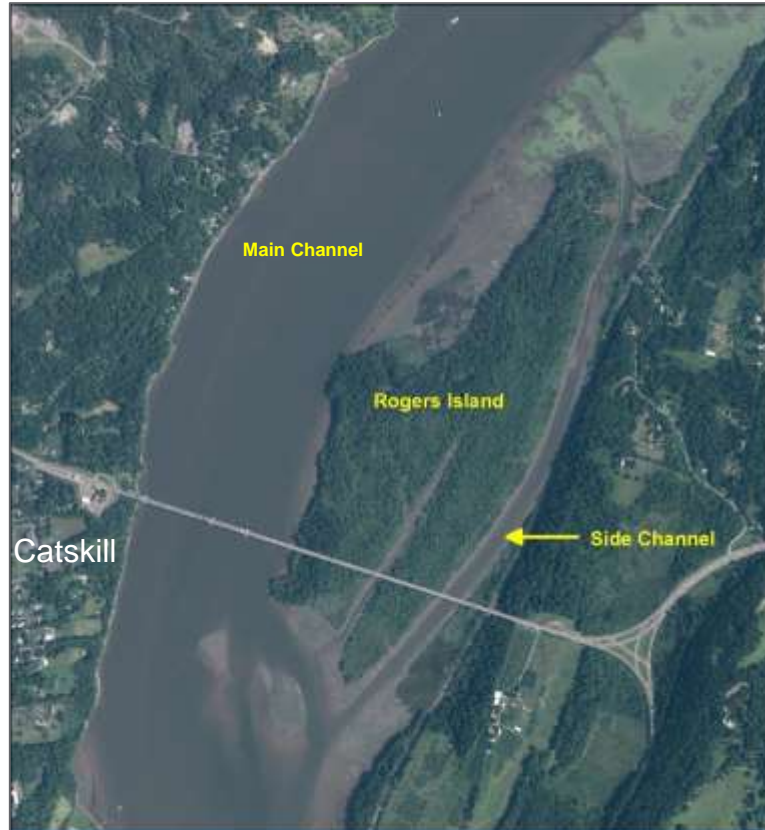
Hallenbeck Creek (Reference Site)

# Historic Losses of Habitat

- River channel straightened and deepened
- Loss of >4,000 acres of shallow water and intertidal habitats
- Near complete elimination of side channels in upper third of estuary

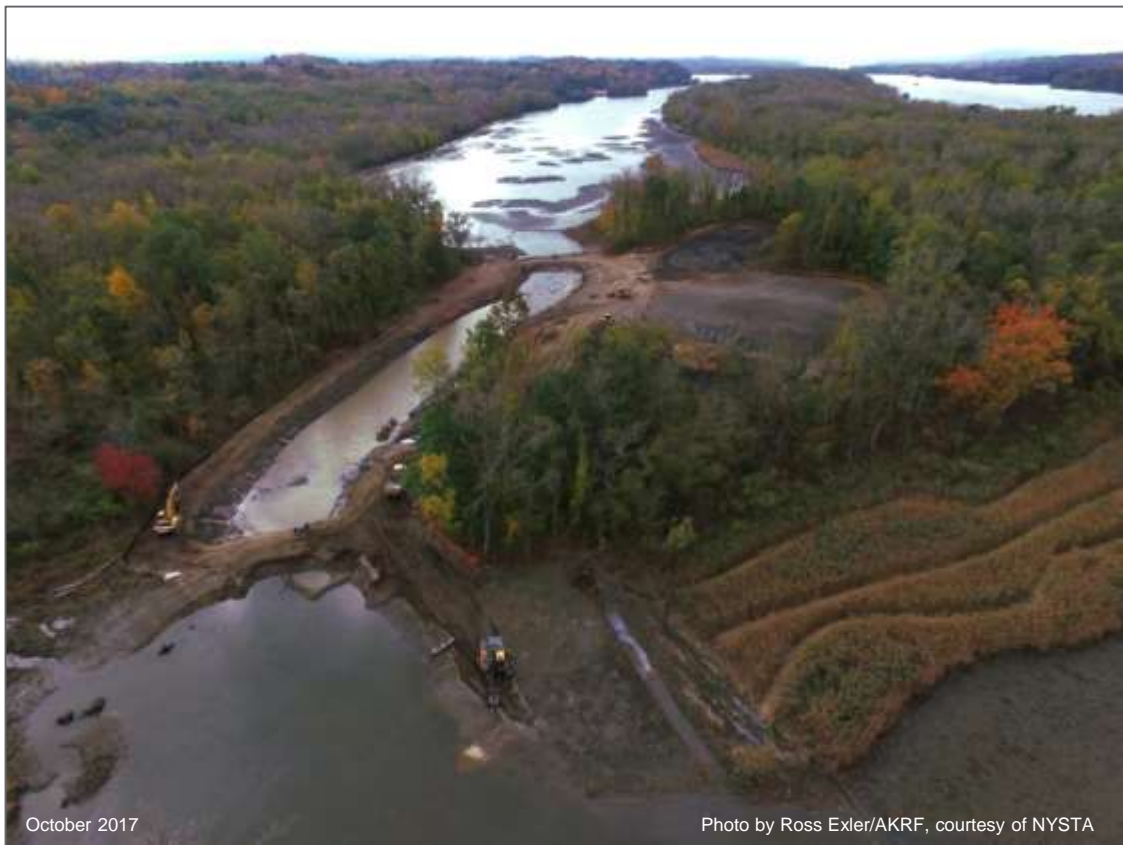
# Side Channel Construction

October 2017

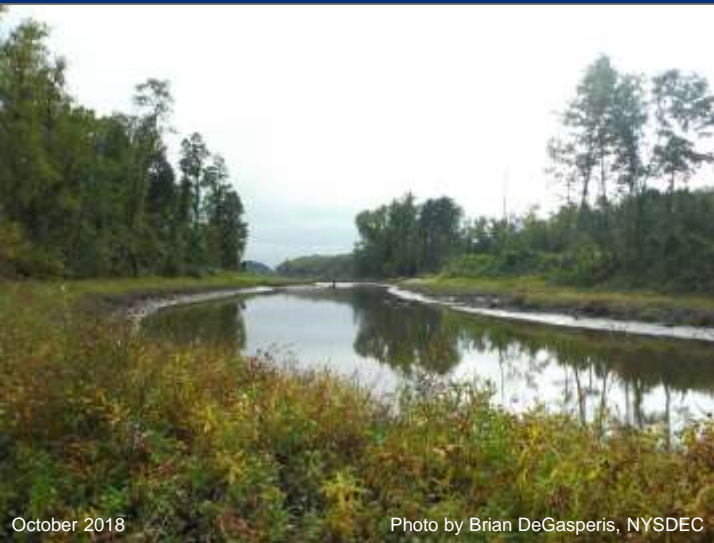
## Channel completed in 2017

- ~ 1,200' L x 100' W
- ~ -2' MLLW

October 2018

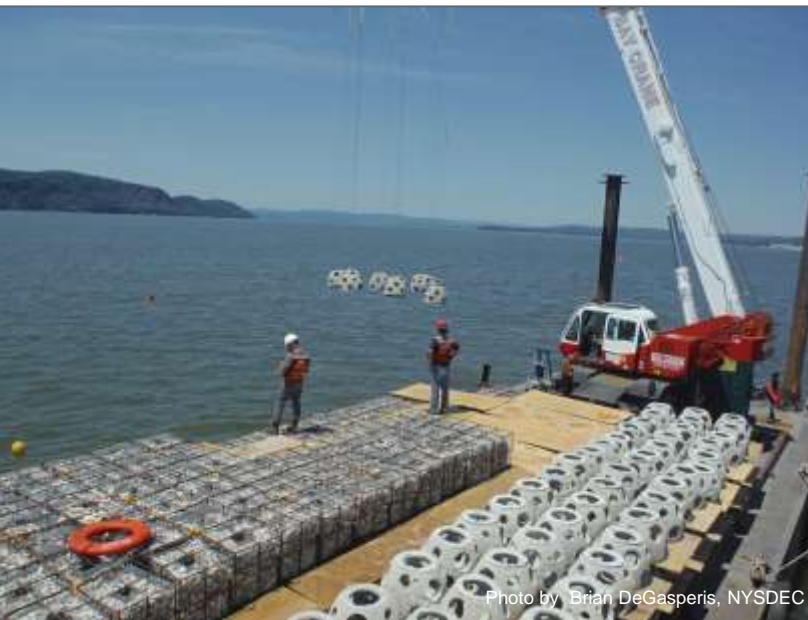
# Reef Construction

- Reefs completed in 2018
- 881 reef balls, 422 gabions
- ~ 5 acres

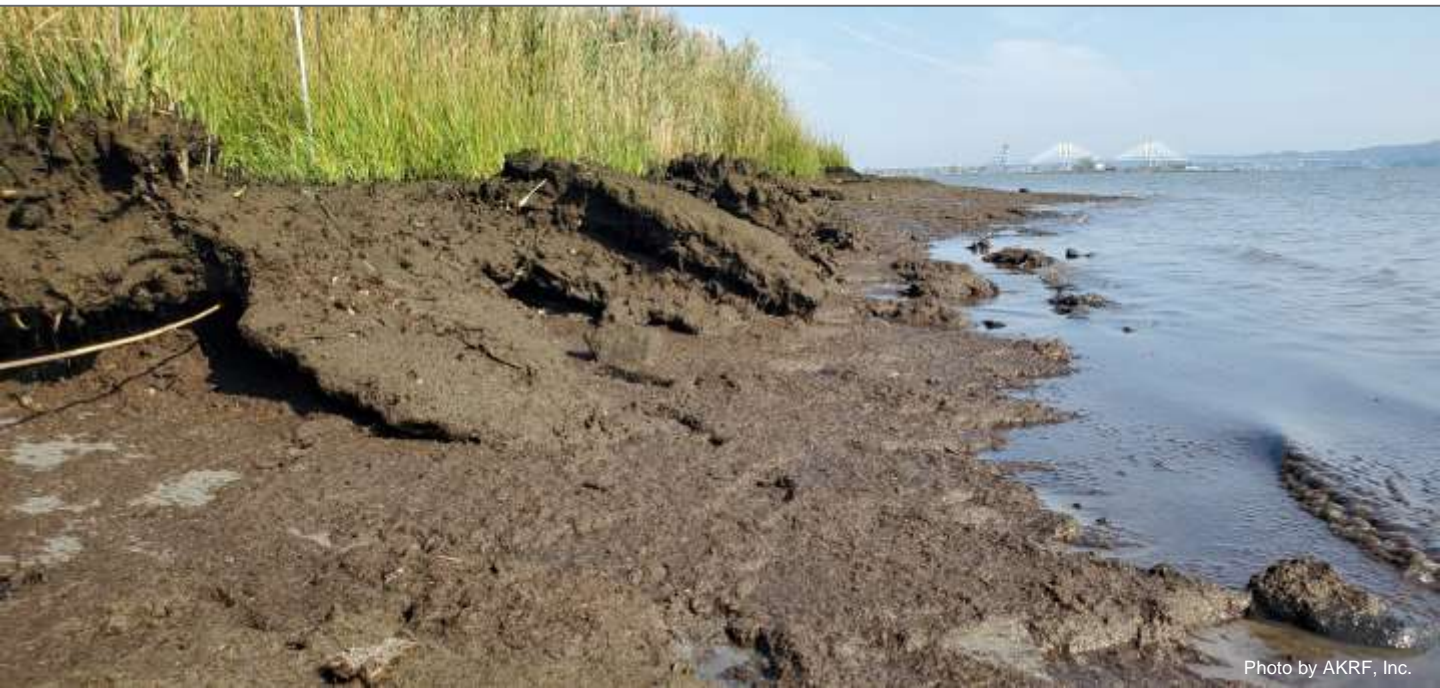
# Marsh Edge Erosion

- At least 50 feet of marsh has eroded since the 1920's
- Losing native *Spartina* fringe
