BE CZAK TIDAL MARSH SHORELINE

OVERVIEW

An eroding shoreline impacted by human use, currents, waves, and ice was reconstructed to include vegetation, varied slopes, and sinuous soft shoreline features. This engineered shoreline protects shoreline habitat and accommodates a boat launch and other recreational activities. It has served as a model for other shoreline improvement projects throughout Yonkers.

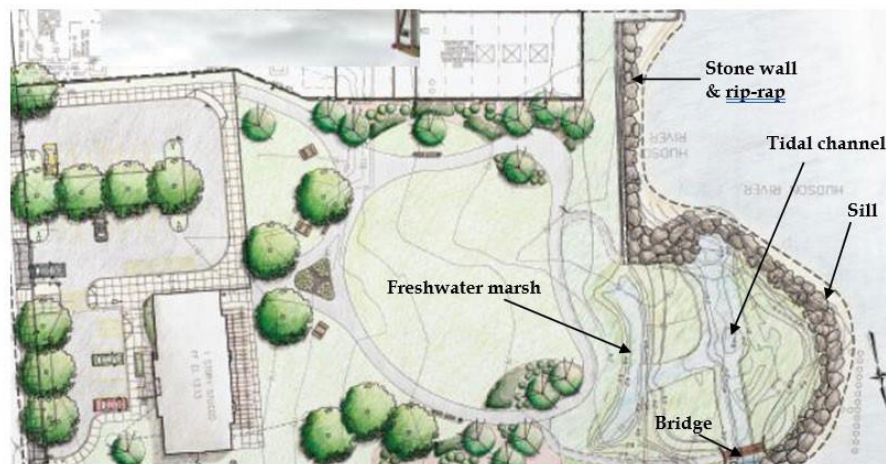
Figure 1: site plan of park including tidal wetland on right (west).
Photos and drawings courtesy of Beczak Environmental Center and Creative Habitat Corp.

To achieve these objectives, the design included a brackish tidal marsh and a beach and dune area that would highlight the differences and interactions between habitats. Diverse native plants were included to attract native fish and animal species and to safeguard the shoreline site from the forces of erosion. Marshes and dunes can provide natural flood and storm surge protection, which is important as the frequency of major storms increases with global warming.

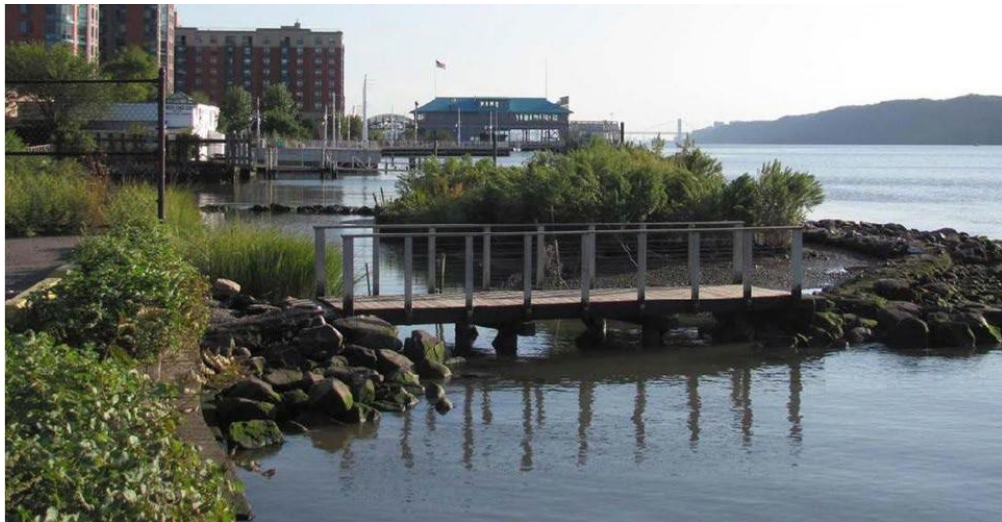
Figure 2: Completed shoreline stabilization and footbridge, September 2012.

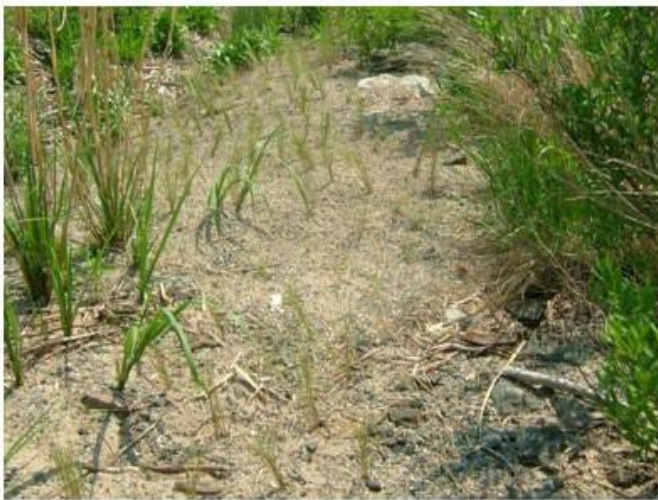
Figure 3: replanting in May 2007 due to geese browsing

The native plant species survived the initial planting. However, overgrazing geese at the site caused extensive damage to the marsh plants. In summer 2007 the marsh grass was replanted and since then it has withstood the continued grazing (figure 5). The cord grasses along the intertidal pool and the successional meadow between the tidal pool and the upland park remain well established (figure 5 and 6), providing valuable intertidal habitat. Although the native plants at Beczak are established, there are areas of the site that still require maintenance and monitoring. The invasive species, Common Reed (*Phragmites australis*), was observed at the site and requires removal to prevent invasion and spread into the marsh. Additionally, an area of meadow was burned near the bulkhead in 2021, but regrowth has already begun. The burned areas should be monitored in future years to examine any patterns as native and non-native plants reestablish.

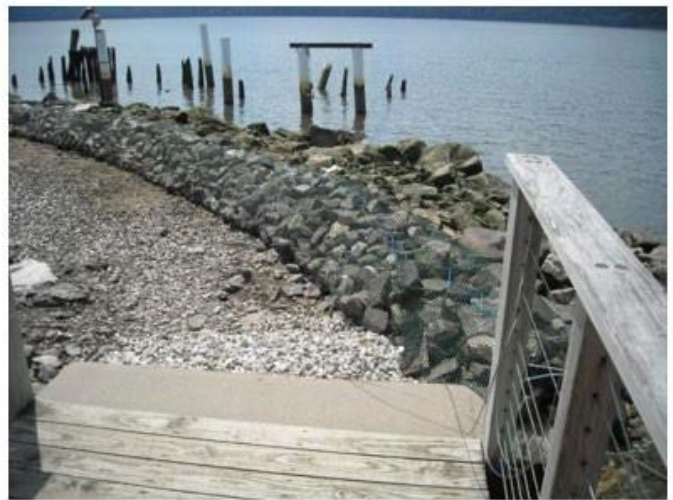
Figure 4: Additional rock added to the sill in 2008 to prevent erosions and control driftwood

The sill proved insufficient after initial construction and needed additional height to protect the marsh from the high energy of the Hudson River. The original sill design did not account for the destructive power of ice or wake from the proximity of the water shipping channel to the shoreline. In summer 2008, additional rock was installed on the sill to prevent erosion and control driftwood and debris from entering the marsh. The site's high exposure to erosion from waves and ice continues to lead to the frequent displacement boulders and cobbles on the far side of the bulkhead and rock sill even after the 2008 sill repairs. However, the sill is sturdy and tall enough to continue to support the tidal pool which provides habitat for many observed species.

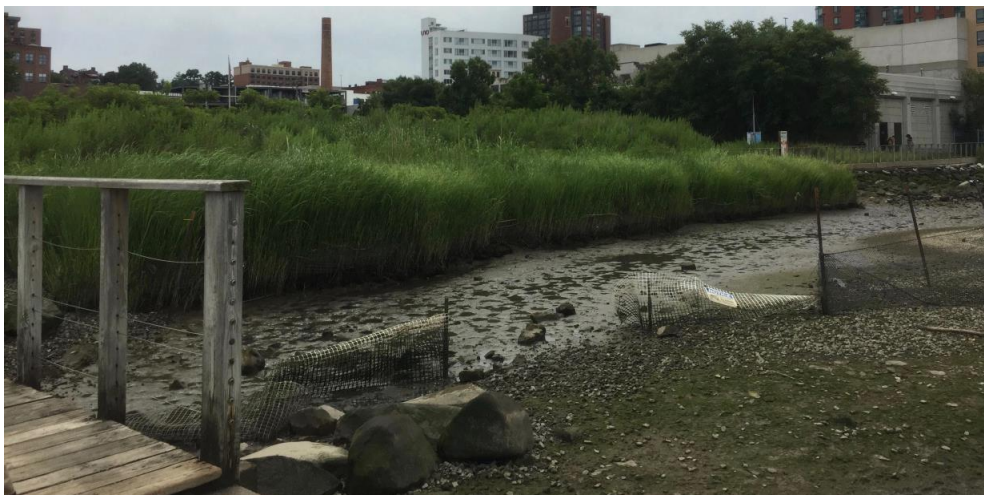
Figure 5. View looking Southeast at the tidal pool and salt marsh grasses in August, 2021. Despite continued grazing of geese that were observed nesting in tidal pool, cordgrass is well established.

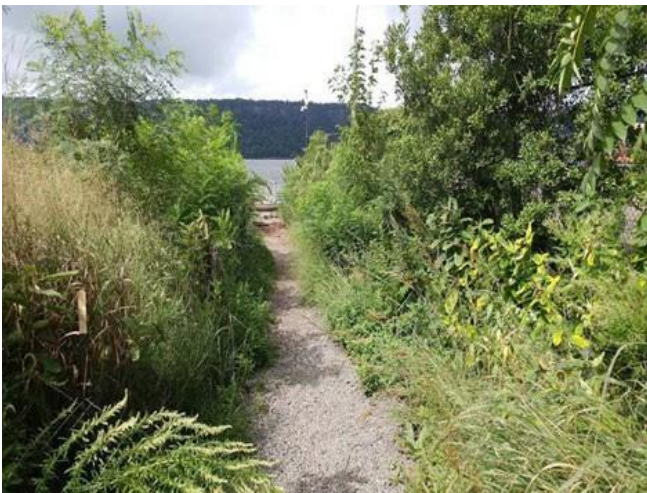
Figure 6: Pathway to the river and tidal marsh shows native plantings

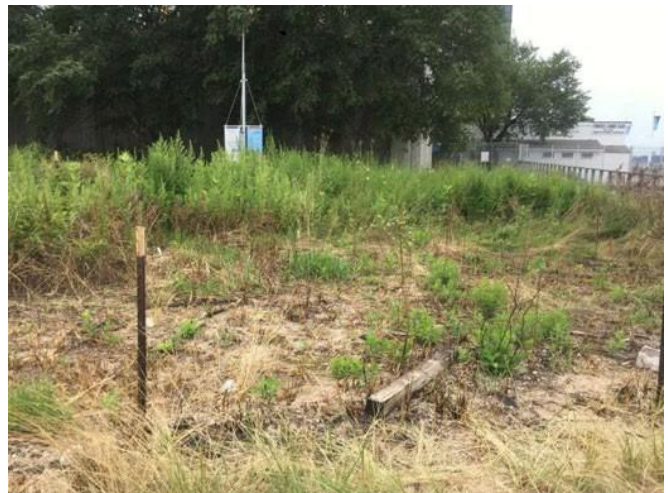
Figure 7: View of the southern section of the meadow where an accidental fire burned vegetation (August 2020)

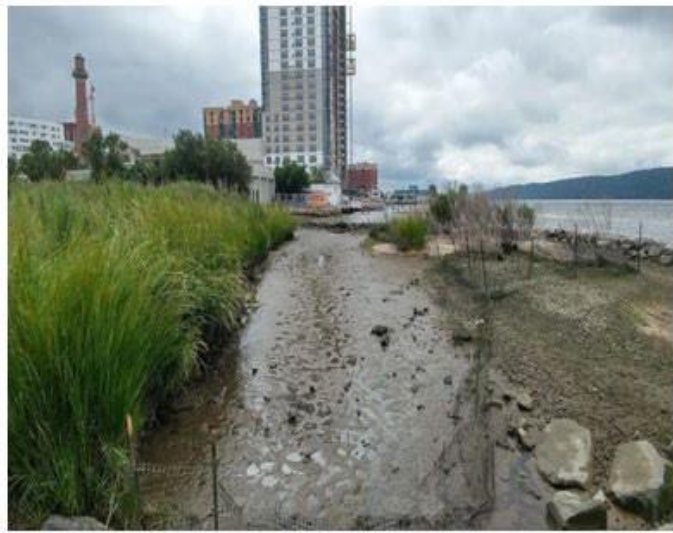
Figure A: despite previous browsing by geese the smooth Cordgrass (left) has become well established (2018)

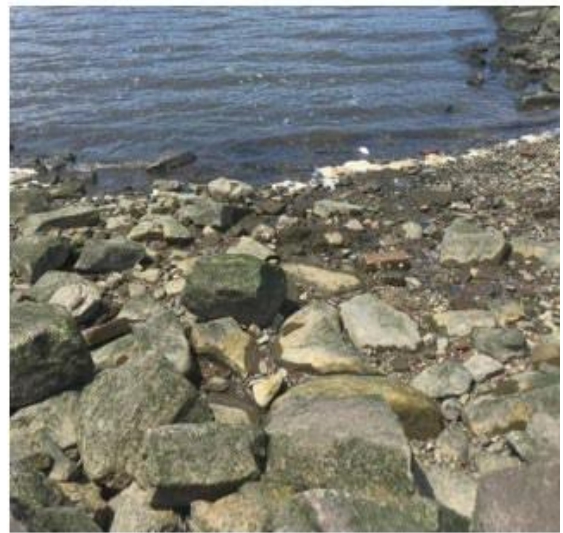
Figure B: View of the seine beach next to the bulkhead, shows boulders and cobbles displaced by waves (2020)

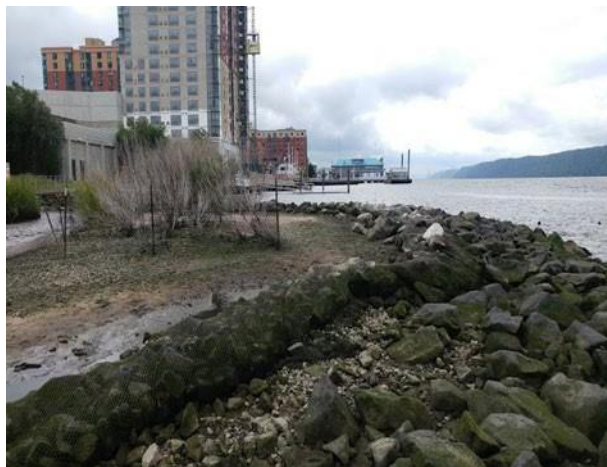
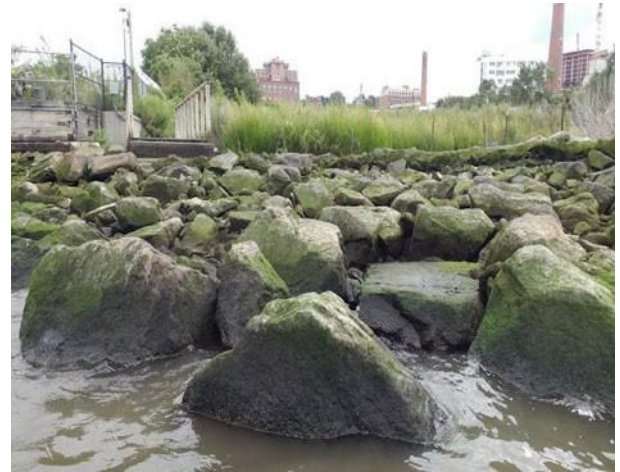
Figure C and D: Left photo looking south at sill, right photo looking east from water at sill and footbridge. Additional rock was installed in 2005 and 2007 to raise the height of the sill. The top layer of rip-rap was enclosed in netting to hold it in place. (Photo taken 9/2018).

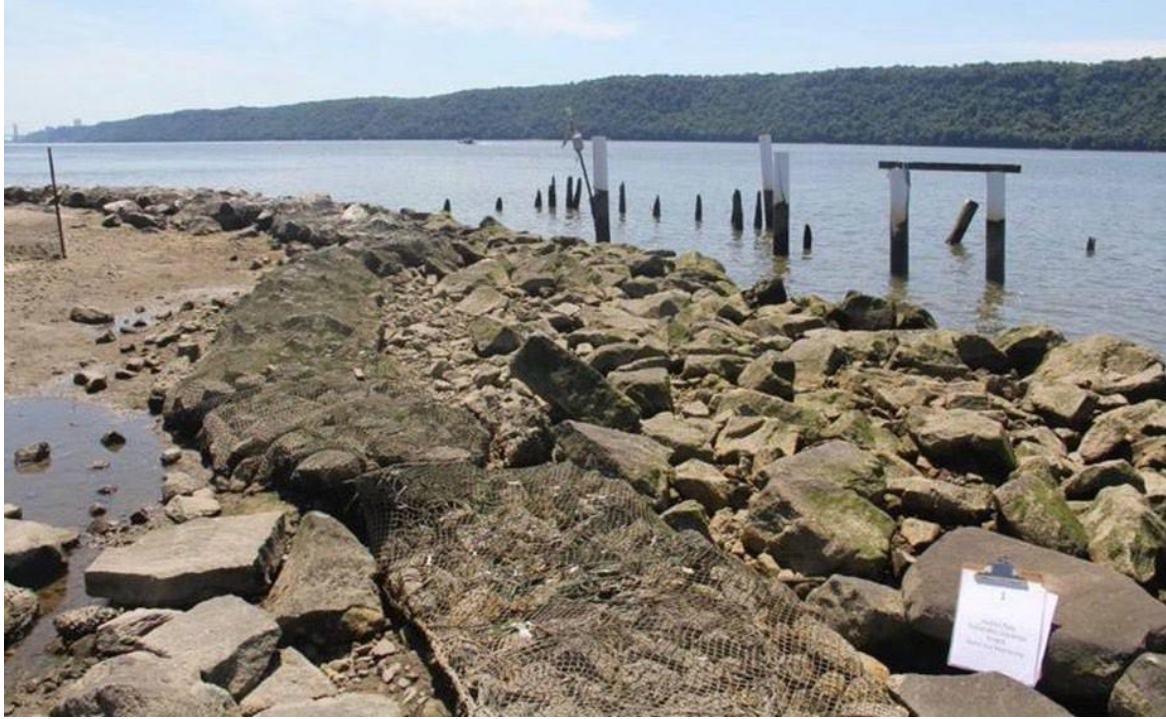
Figure E. View looking southwest at the rock sill in September, 2020. Rock sill continues to provide a protected tidal pool environment. While the netting that encloses the top layer of rip-rap remains intact, some boulders and cobbles without netting have been displaced on the sill.
